# Hurricane Ian Study

Jim LaDue

Acting Director, NWIRP

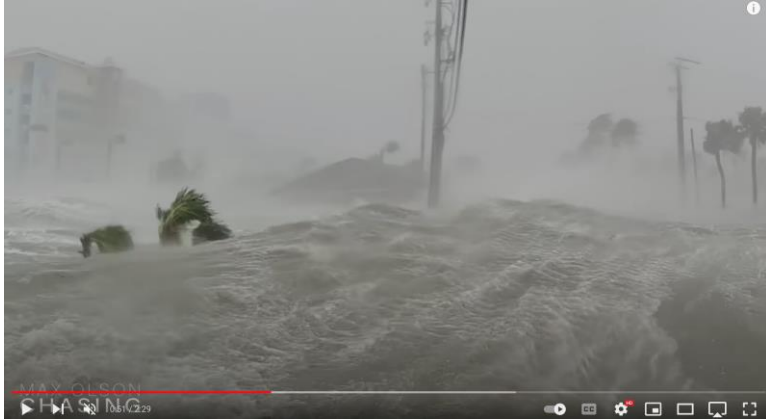
## Waves

No measurements during or after the storm

Conservative estimates are made with wide error bars

Relatively low confidence guidance in ASCE7 evaluating damaging debris

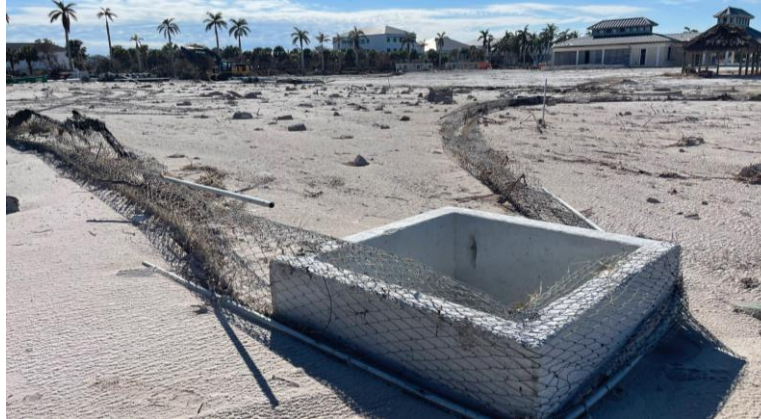
## Flow Velocity

No measurements during or after the storm

Conservative estimates are made with wide error bars

Relatively low confidence guidance in ASCE7 evaluating damaging debris

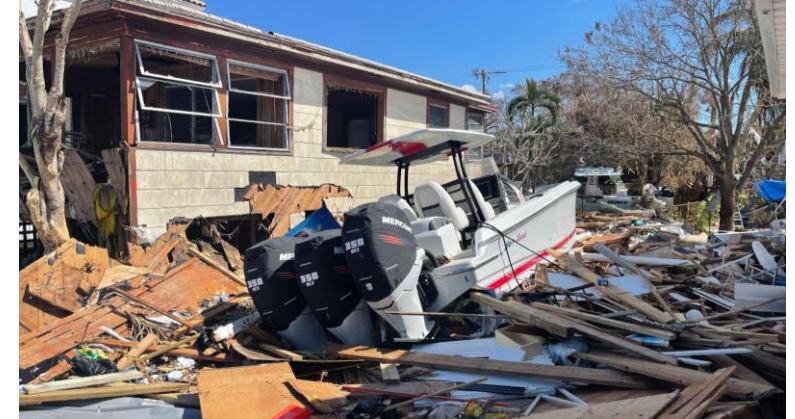
## Debris

Limited data collection during or after the storm

Includes loading and impacts

Relatively low confidence guidance in ASCE7 evaluating damaging debris
